Philes' Forum

Hello Bimmerphiles. Sorry to have been absent from the February Bulletin. This time out we continue with our saga of replacing E30 rear-subframe bushings.

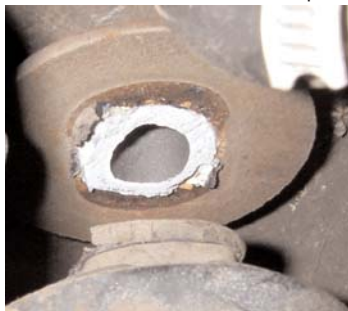
In the January *Philes' Forum* we left a poor E30 up on the lift with the inner sleeve of a rear-subframe bushing broken off and stuck in the car's unibody. Yikes! See Photo #1.

Photo #1 Yikes!

The first step in removing the broken-off part of the bushing inner sleeve is to remove the bushing from the subframe. Photo #2 shows the Chapter's bushing tool doing just this. Be sure to remove the spacer washer from the upper end of the subframe bushing prior to fitting the removal fixtures. The bushing is pulled from the subframe by tightening the nut shown near the bottom of the photo. Be careful, because the bushing and heavy removal fixture will want to fall to the ground when the bushing pulls free of the subframe; so be sure to restrain them from doing so.

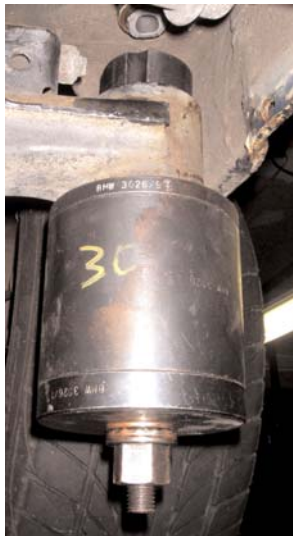
Photo #2 Extracting old bushing

Note that undue torque is not required to pull out the bushing. A high required torque probably indicates that part of the removal fixture is jamming in the subframe, putting the threads of the removal fixture at risk of stripping. So keep this in mind and realign the removal-fixture pieces as required.

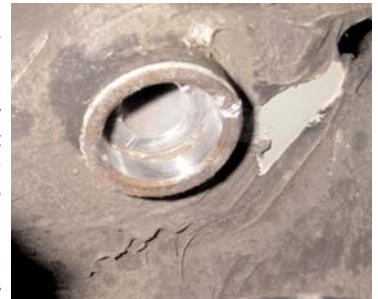
Photo #4 All dressed up and ready to go.

With the bushing removed, you can chisel out the remains of the broken inner sleeve from the socket in the unibody using a long chisel applied upwardly through the space in the subframe vacated by the removed subframe bushing. I use a long chisel bit in the pneumatic hammer [See Photo #3], but it can be done by hand if you are patient and have a long enough chisel. Photo #4 depicts the socket in the unibody all cleaned out and ready to receive a coat of anti-seize compound and the new subframe bushing.

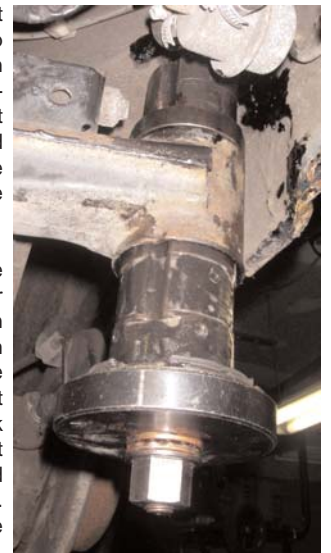
Photo #5 Installing the new bushing.

resided, you are ready to press in the new bushing [BMW Part # 33-31-1-129-144]. See Photo #5, which shows the Chapter's bushing tool reconfigured to install the new bushing, again by tightening the nut near the bottom of the photo. Note that considerably less torque is required to press the new, lubricated bushing into place than was required to extract the old bushing. Photo #6 depicts the new bushing pressed fully into place.

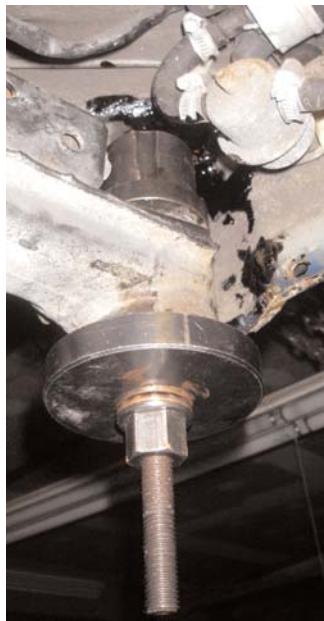
Photo #6 New bushing pressed into place.

Raise the subframe, ensuring that the upper end of the subframe-bushing inner sleeve fits into the unibody socket. Then drop the 14-mm stud back down through the subframe bushing from inside the car, and reinstall the bushing-support plate. With the subframe-support jack still in place, install a new 14-mm nut [33-33-1-126-136] on the stud and torque to 140 newton-meters [101 lb.-ft.]. I like to retorque these after driving the car a bit.
